AUTOMOTIVE CONSULTING ENGINEERS LTD

CONFIDENTIAL TECHNICAL REPORT

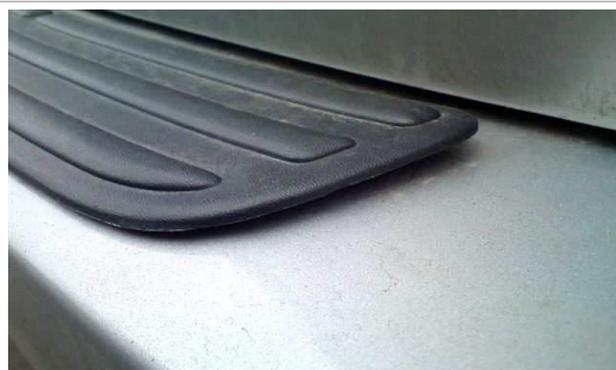
Rear bumper tread plate adrift

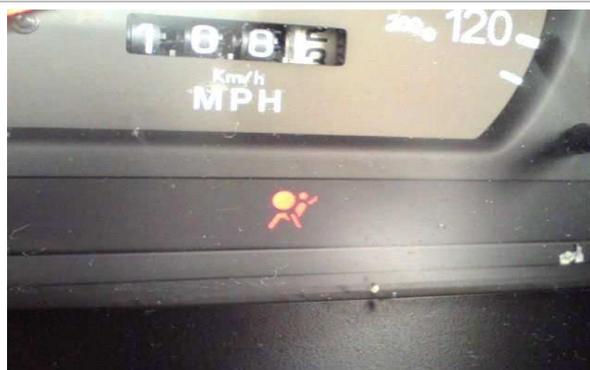
R7	The hirer indicates that he still has outstanding issues, the first being that the air bag warning light is illuminated.
R8	We can confirm at the time of our inspection, the air bag warning light was illuminated.
R9	The vehicle will need to be submitted to a specialist or to a dealer for investigation of the condition.
R10	The air conditioning was found to be inoperative.
R11	On testing the air conditioning, we can confirm it was inoperative at the time of our inspection and again, needs further investigation by a specialist repairer or dealer.
R12	The vehicles service record was missing.
R13	To rectify this, the service book will be required and suitably stamped. However, it may not be possible to get the vehicles service history apart from contacting the previous owner.
R14	The hirer also indicates that an engine noise is apparent
R15	We started the engine from its ambient temperature and can confirm it did appear audible. However, the noise level did not appear excessive.

SRS/air bag warning light on dash

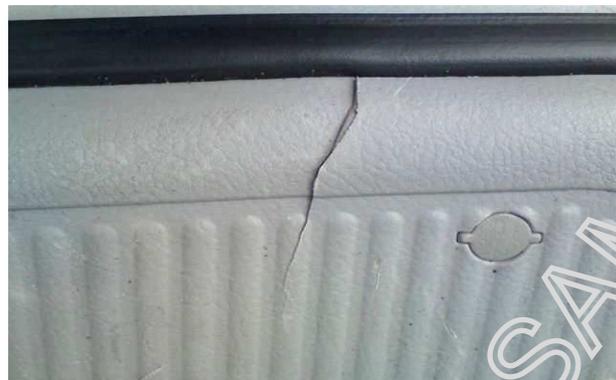
Rear boot space trim cracked

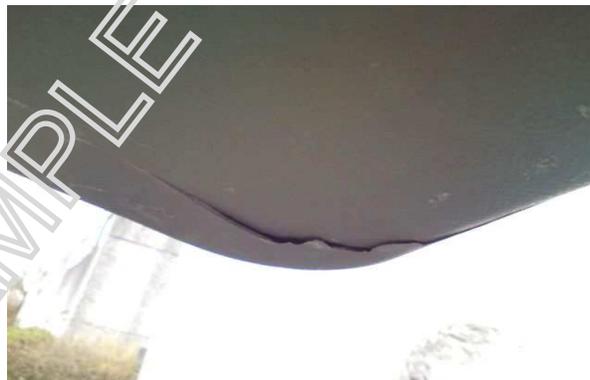
Tailgate trim panel cracked
